## **Sakhalin II Project On-site Inspection Report August 2006 by Hokkaido Raptor Research**

### **Inspection Itinerary:**

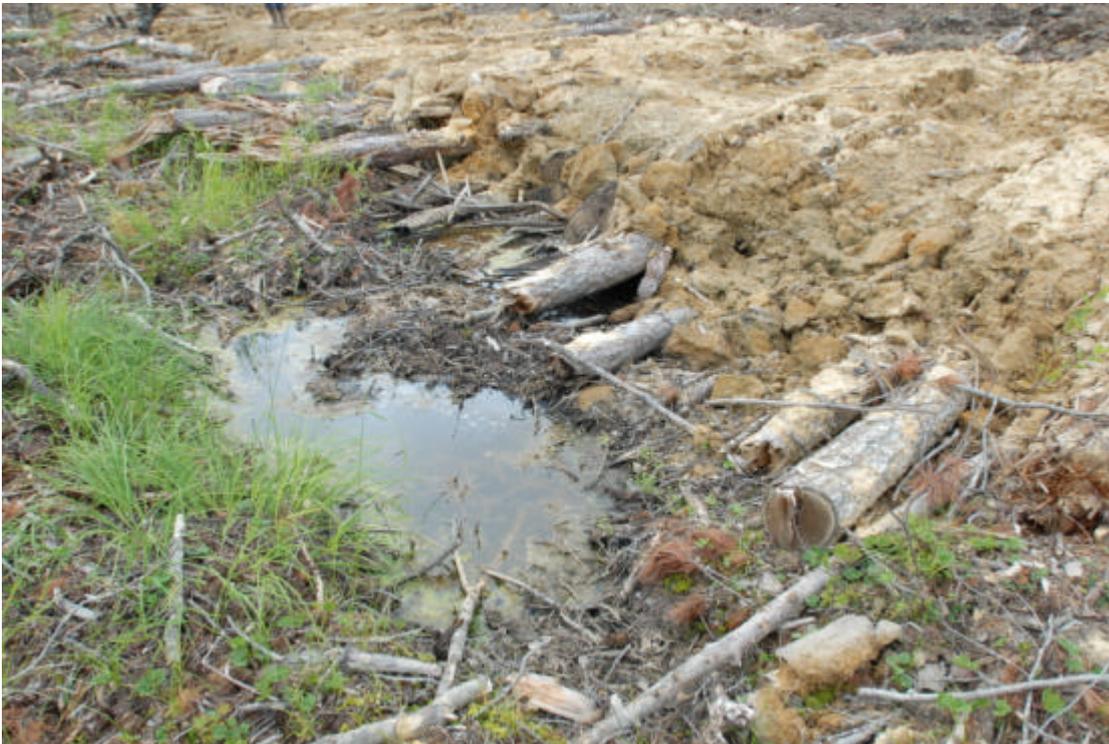
- We observed a considerable amount of soil eroding into the wetland habitat where Spotted Greenshank was found and Sakhalin Energy Investment Company (SEIC) identified as a key habitat. According to SEIC, the destruction was caused by the Exxon pipeline which runs parallel to the SEIC's, but there is already a construction road crossing streams along the planned pipeline route, and the influence of their construction is rather evident. Incidentally, SEIC insists the rivers in this area are small streams without salmon and trout spawning, and therefore, the river system itself is not an object to be protected.

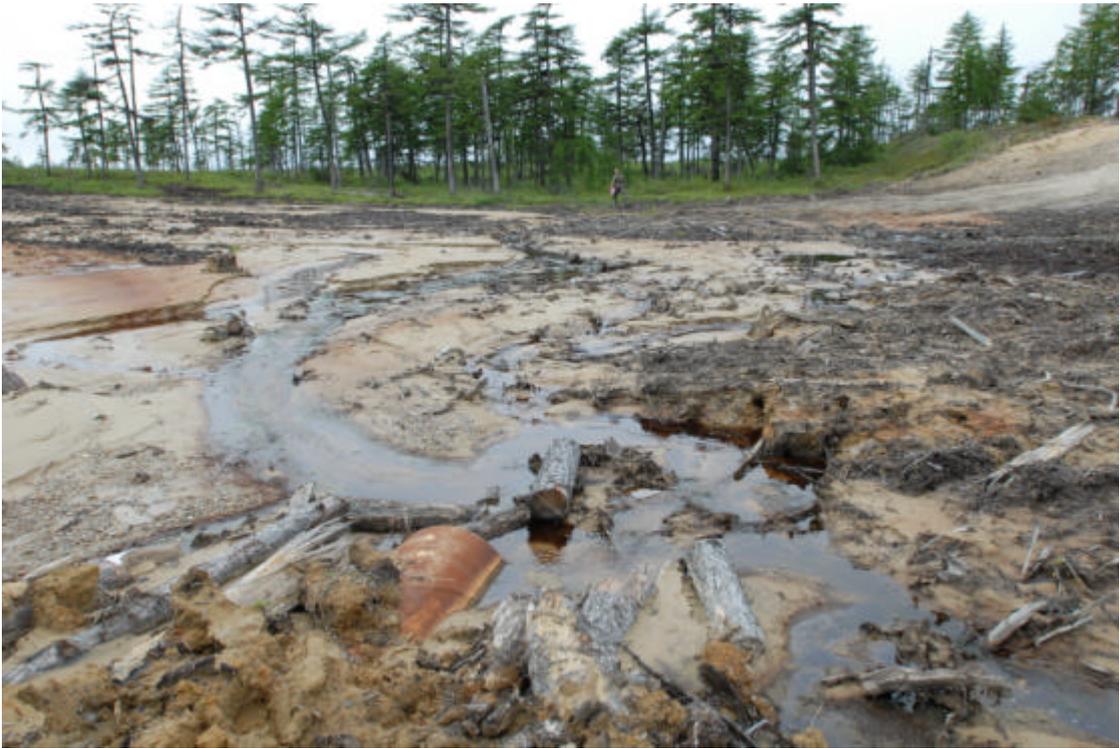
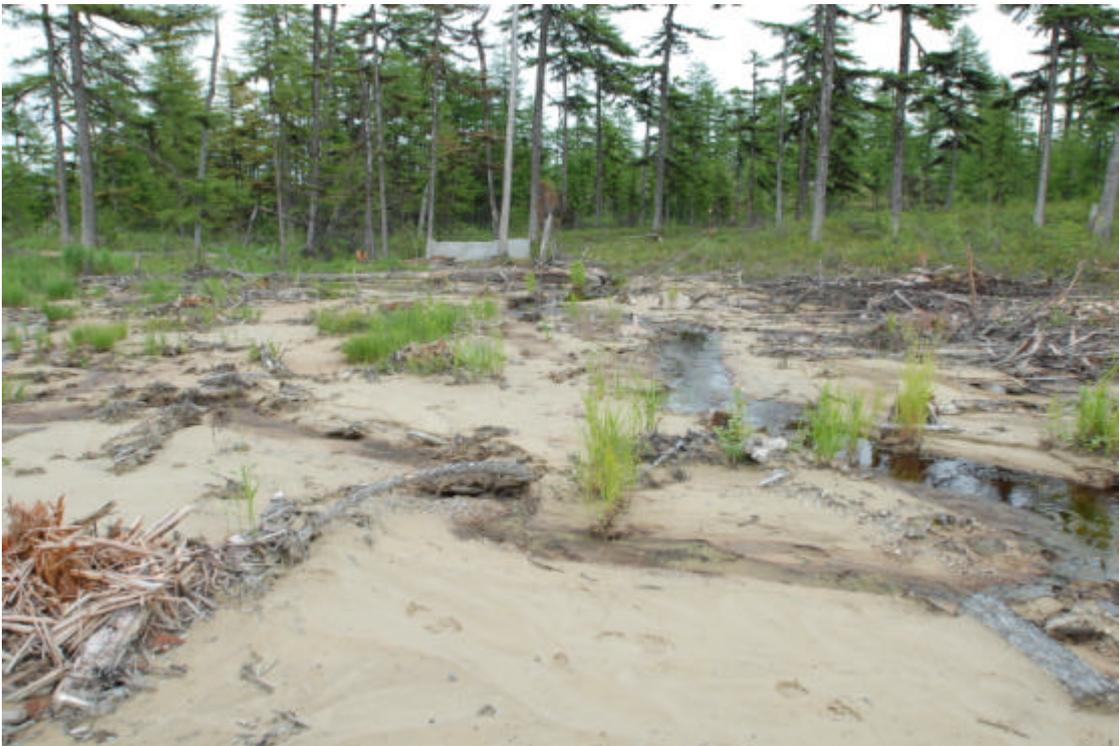
- The pipeline construction which was supposed to be limited during winter time (until March 15<sup>th</sup>, according to a SEIC's on-site staff member) due to the nesting activities of Steller's Sea Eagle was actually extended by 1 month, until April 15<sup>th</sup>, which we were told by SEIC's employee (management level). They explained that they had obtained an approval from Dr. Vladimir Mastrov (a Steller's Sea-Eagle researcher) who was their advisor. It means that their EIA (and its addenda) which SEIC insisted as the results based upon researches of many experts, and supposed to be the 'Constitution' and to be respected the most in their construction planning had been easily retracted by an opinion of a single researcher, to speed-up the construction.

- On the sand spit on the other side of Chaivo Lagoon, most of the pipeline construction were already completed. The pipes laid under water through the wetlands, small lakes and ponds were only treated with surface coating. We did not recognize any special measures taken to prevent oil leak accidents.

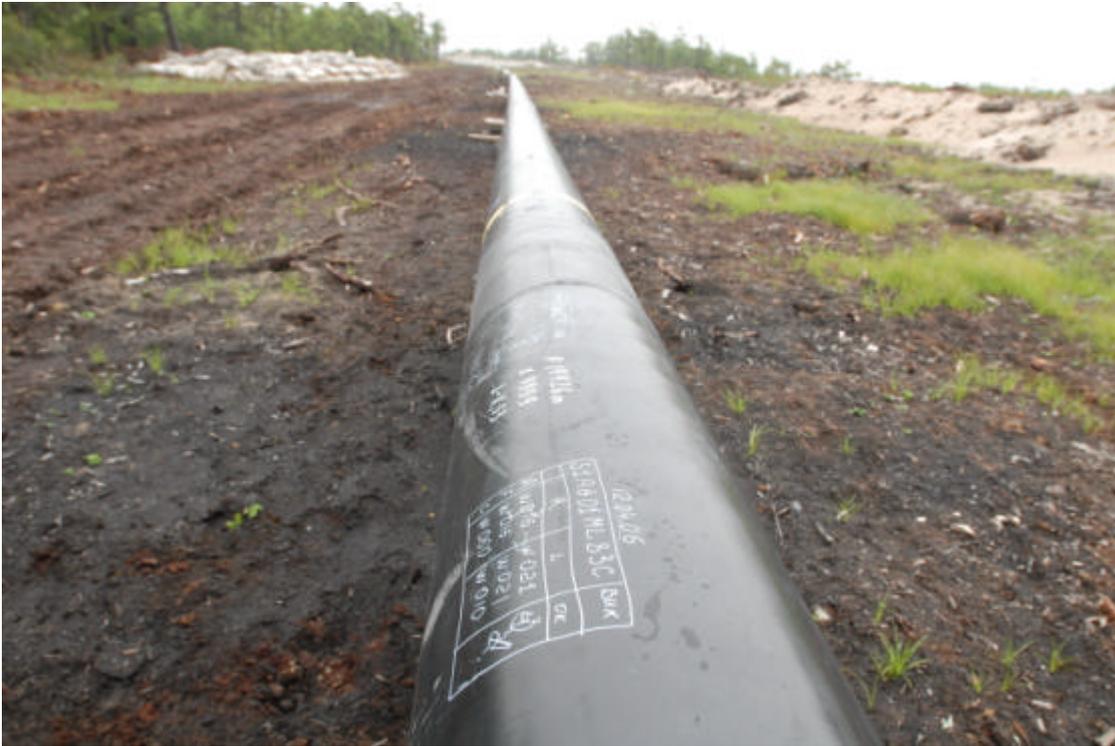
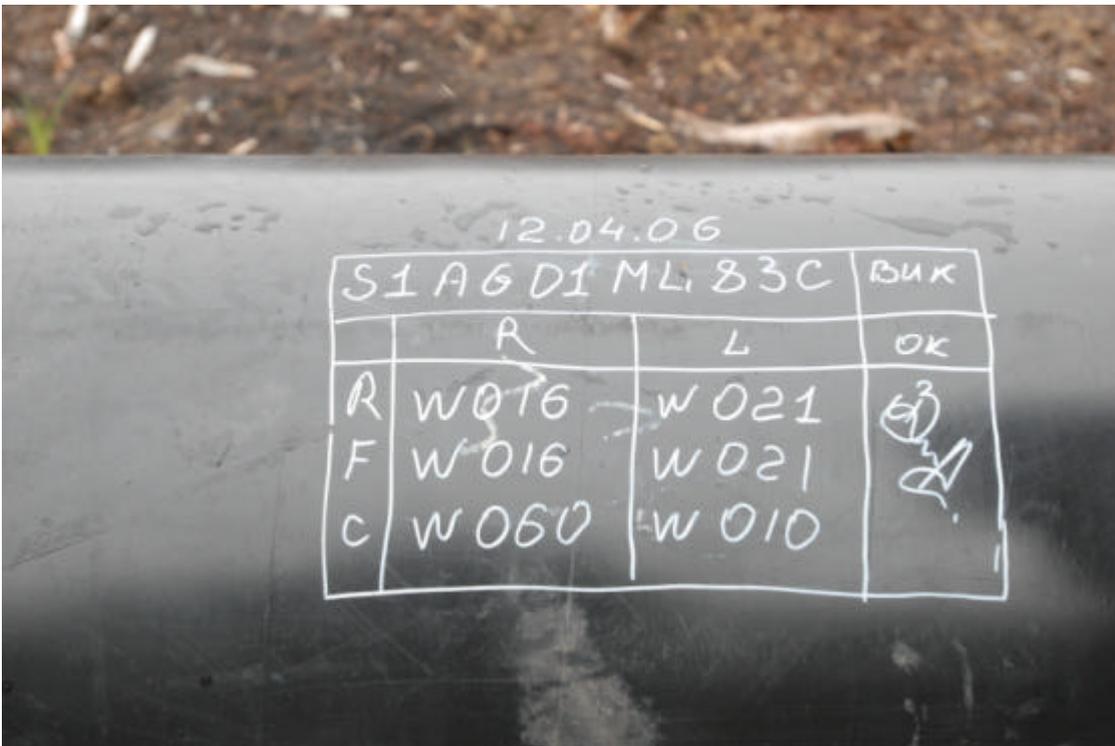
- We observed pipelines constructed only 300 m away from a nest of Steller's Sea-Eagles on the spit across the lagoon. SEIC's on-site staff member explained to us that no construction activities had been taken place within 700 m radius from the nest after March 15<sup>th</sup> as a mitigation measure. We read, however, the work completion date written on 2 pipelines (2 sectors) were April 12<sup>th</sup>, 2006. (Both of

them were newly printed beside the old dates of mid March. )

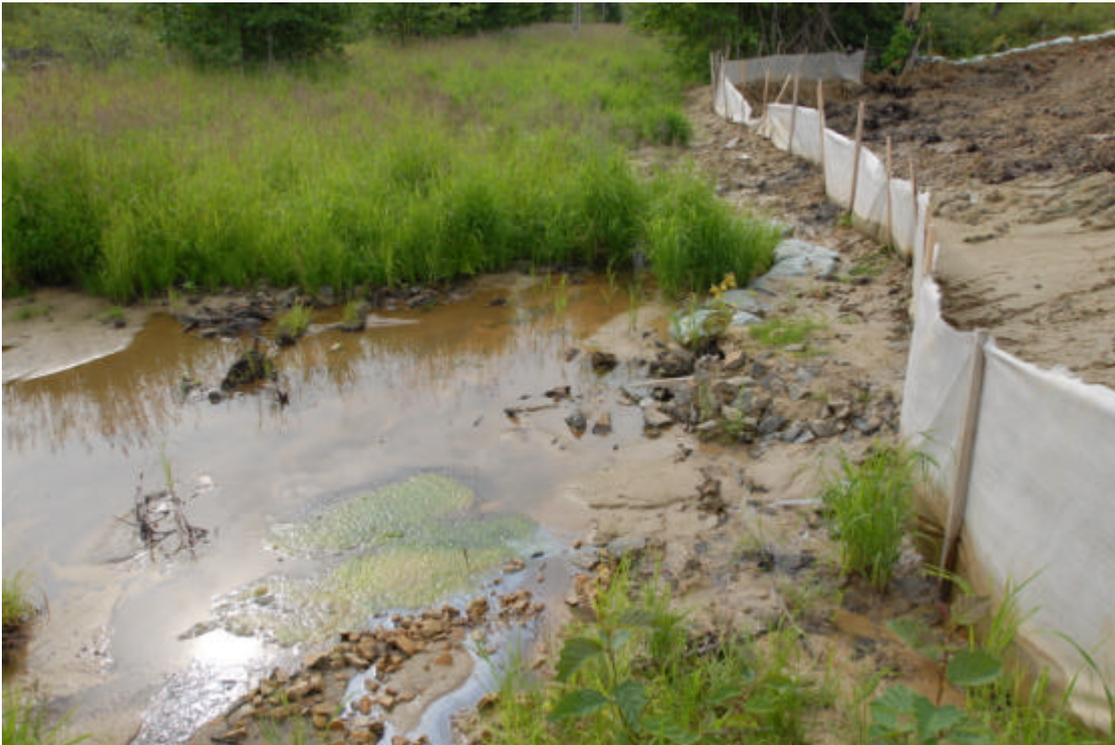
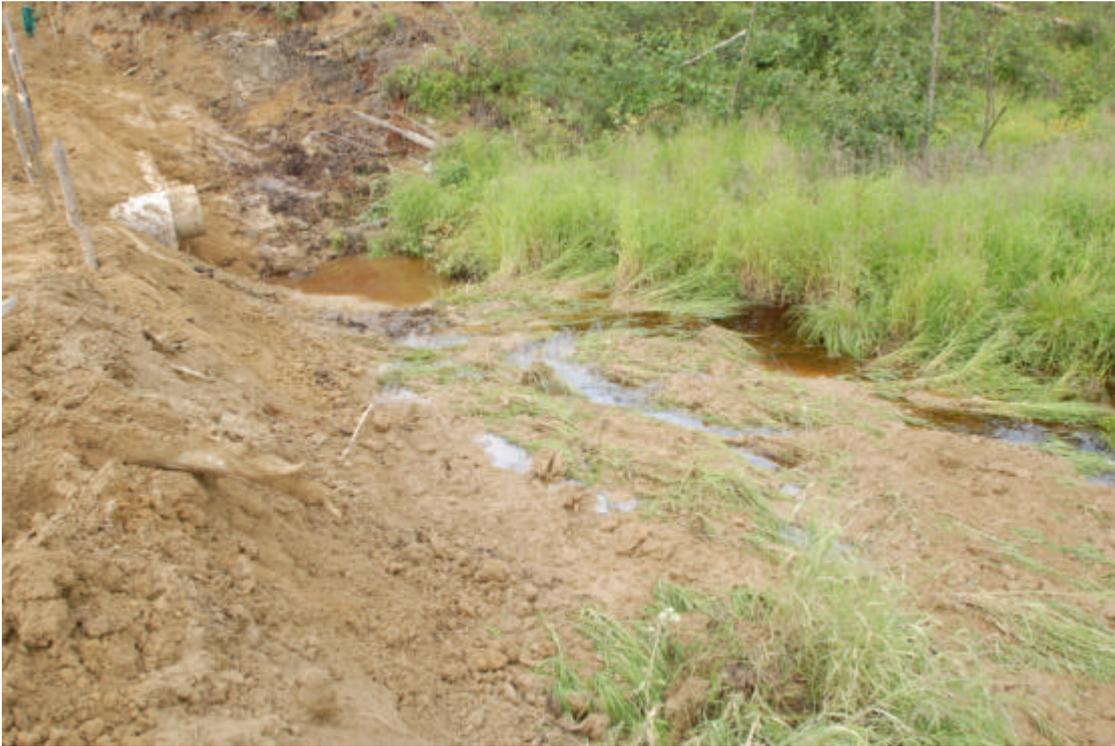
- We observed soil eroding into marshes along several streams which were supposed to be non-salmon/trout spawning rivers (including some streams with treatments done). An on-site staff member of SEIC clearly stated that even for the salmon-trout spawning rivers where some mud-blocking treatments were installed, it will be necessary to repair those fences (made of cloth) at every rainfall. We can speculate that soil erosions into rivers/streams and marshes were extremely common.

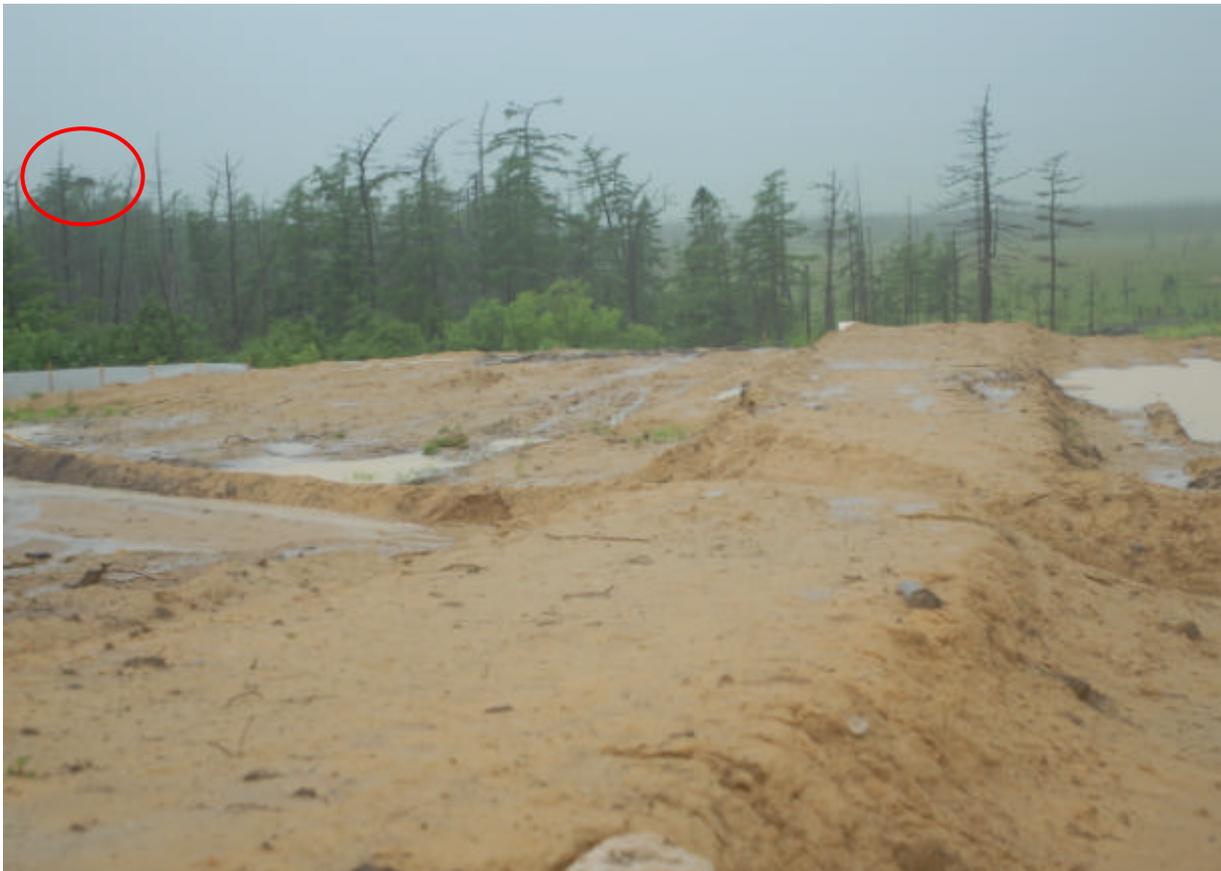
- We observed an active nest of Steller's Sea-Eagles approximately 100 m from the (pipeline) crossing over Tomi River, which flowed into Dagi Lagoon (we confirmed at least one fledgling in the nest). Besides this active nest, we observed another nest of the same pair within 100 m across the pipeline (we confirmed one adult bird near the nest). Also, a few hundred meters farther from the nest, a third nest which most likely belonged to the same pair was observed. It indicated that the pipeline was dividing the breeding pair's exclusive nesting territory (crucial area necessary for reproductive activities) into two. The nesting territory was located in riverside forest only left among the wide area burnt by wild fires, and it could be assumed there were very few other places left as good nesting sites except this location. Furthermore, as we observed more than one nest within extremely close range. It was apparent that the pair had been using this location as a nesting site for many years. It is very difficult to understand why this location was not avoided during the pipeline route planning.

Steller's Sea-Eagle's active nest in circle

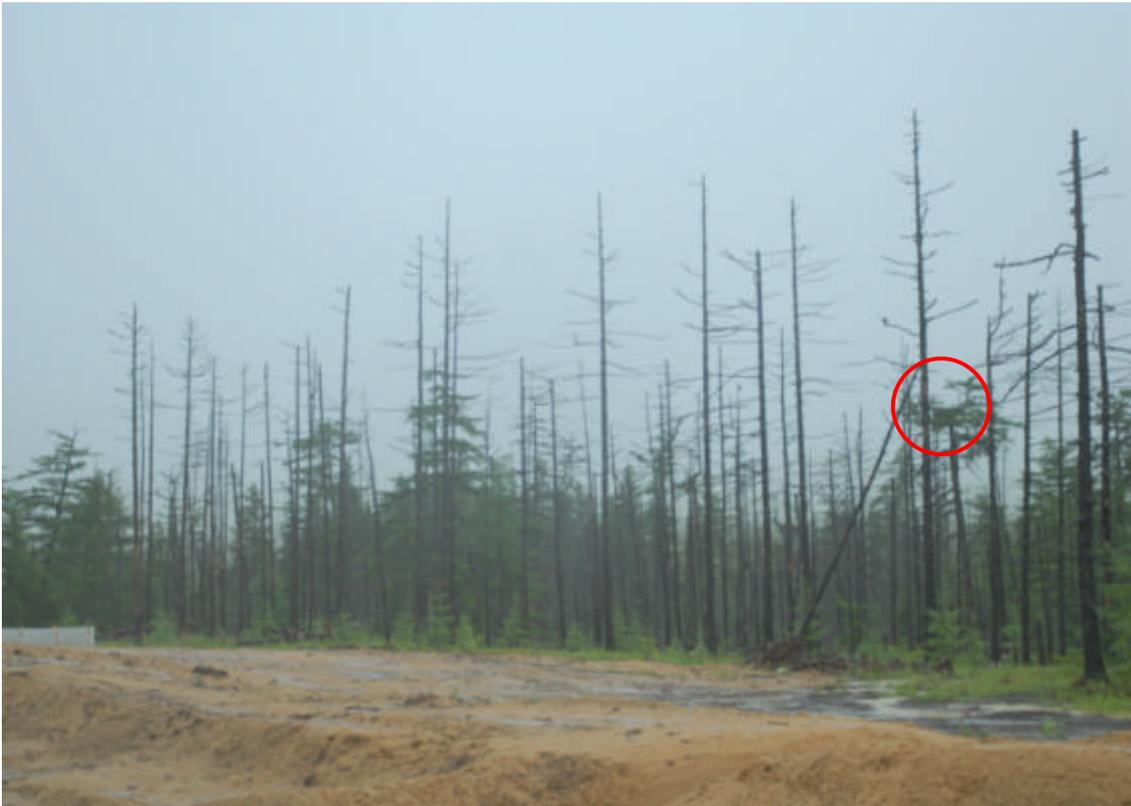
Steller's Sea-Eagle's nest in circle

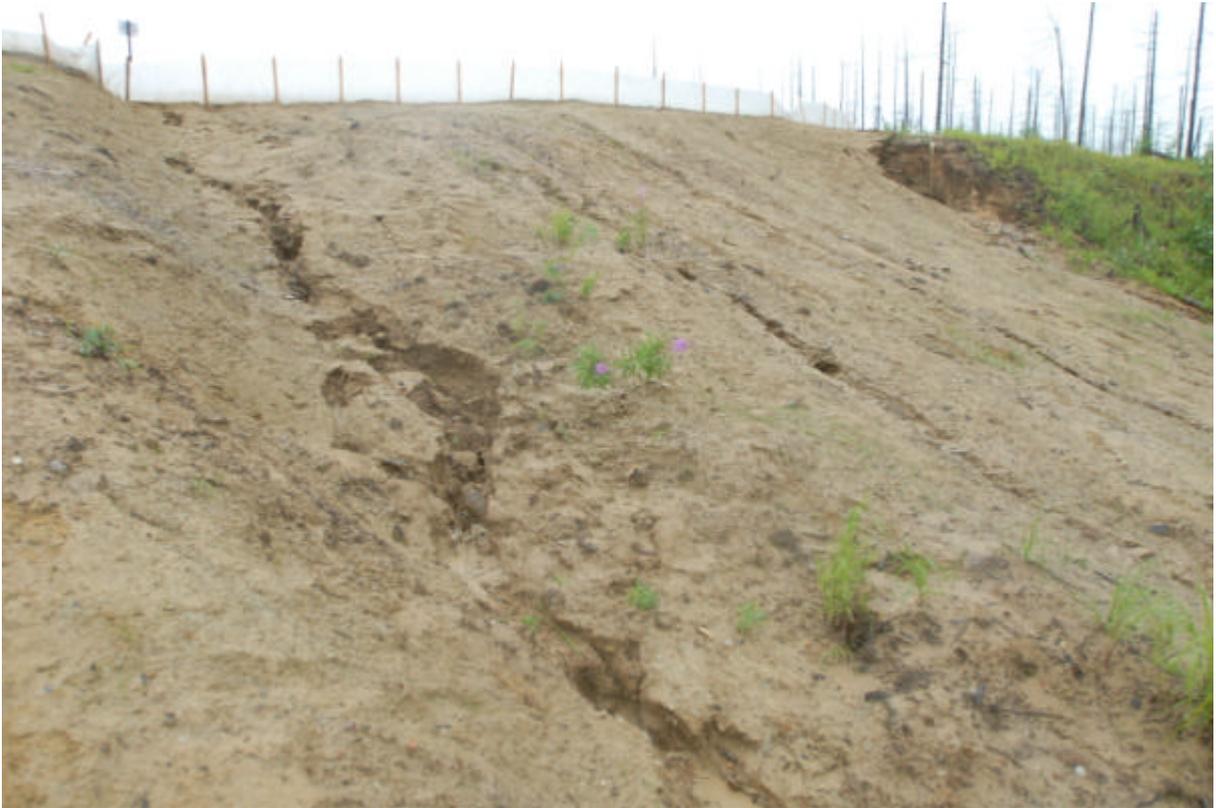
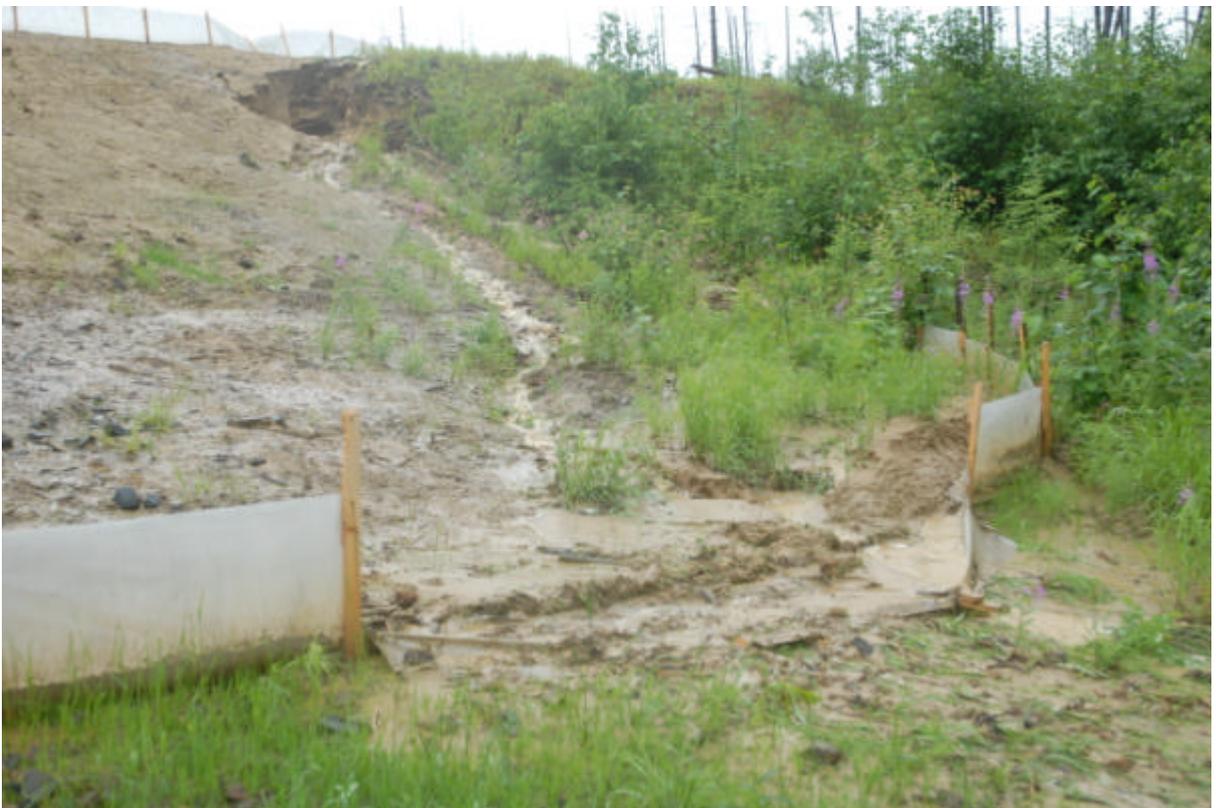
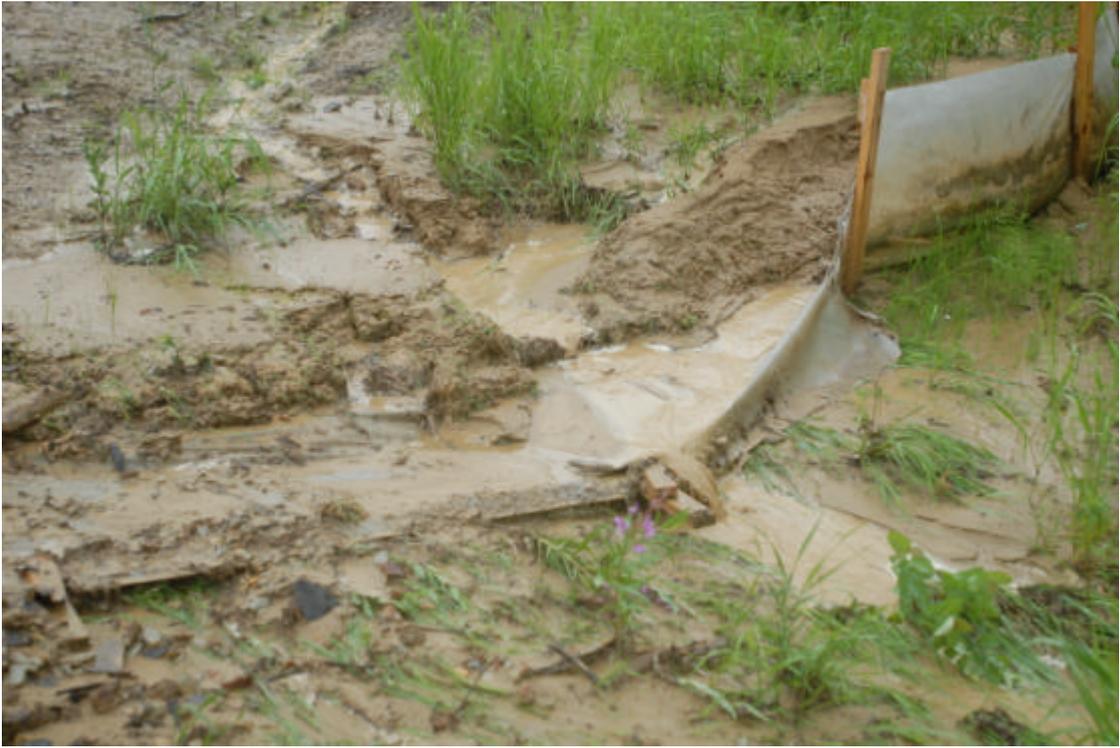
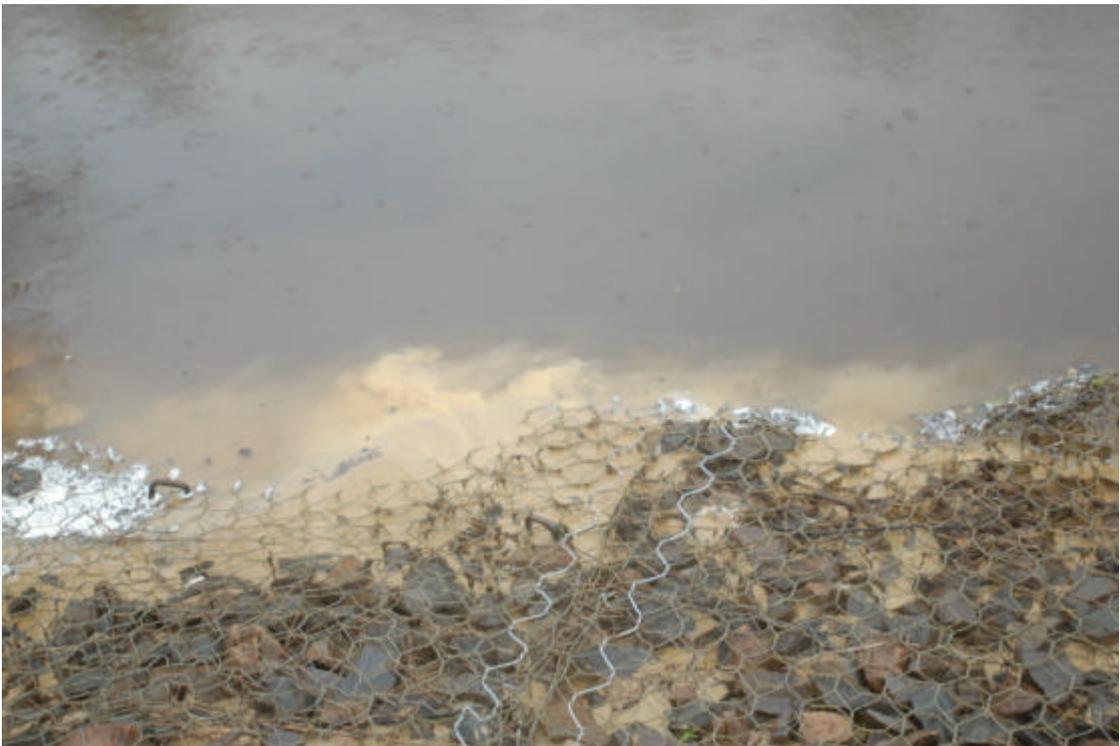
- The construction work on the pipeline crossing Tomi River had been mostly completed in winter time, but we observed several cases of soil erosions and mud inflows into river systems on bare river banks. The company employee stated that they could not do maintenance work as the sites were close to eagle's nests, but the cause of the problems was the pipeline itself which they had constructed in the Steller's Sea-Eagles breeding range in first place. We think this kind of problems were predictable beforehand, and it is interesting to hear what kind of maintenance procedures were being planned for this area.
