## **Sakhalin II Project On-site Inspection Report August 2006 by Hokkaido Raptor Research**

### **Inspection Itinerary:**

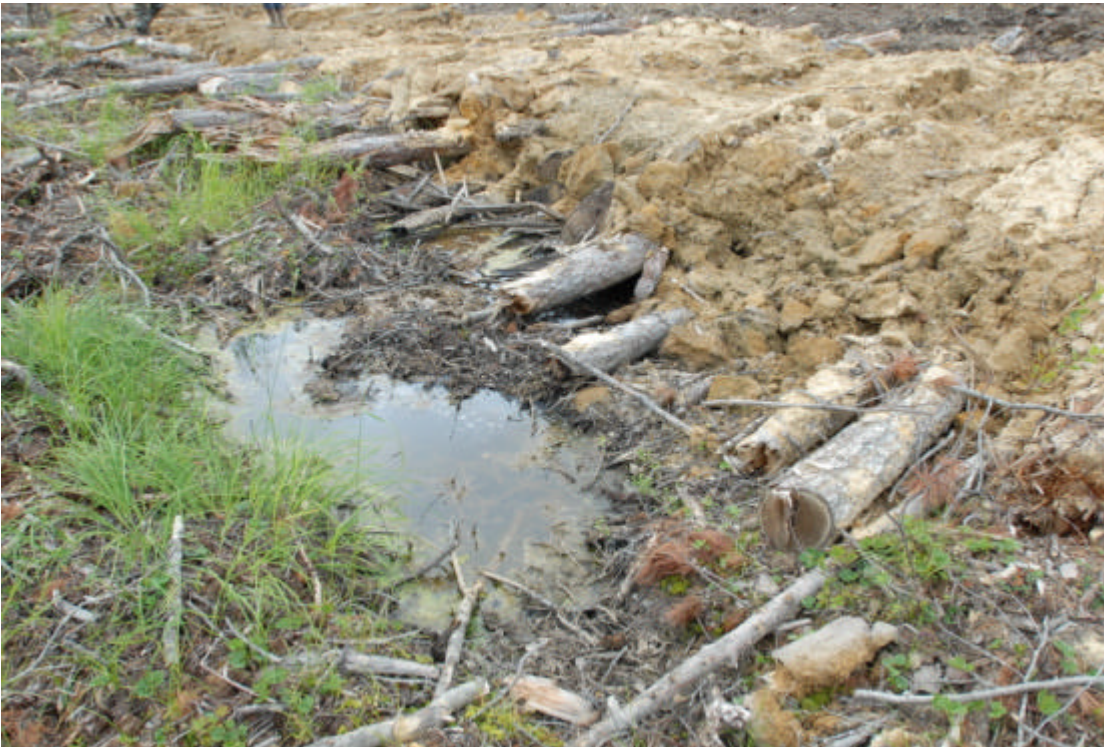
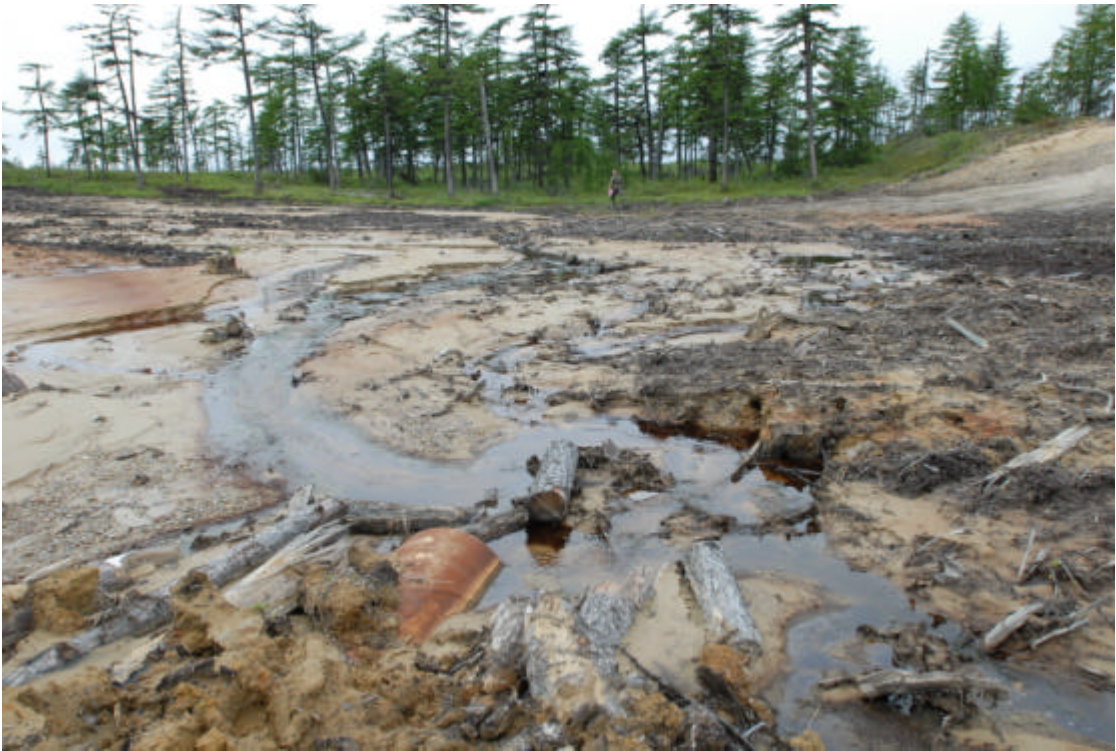
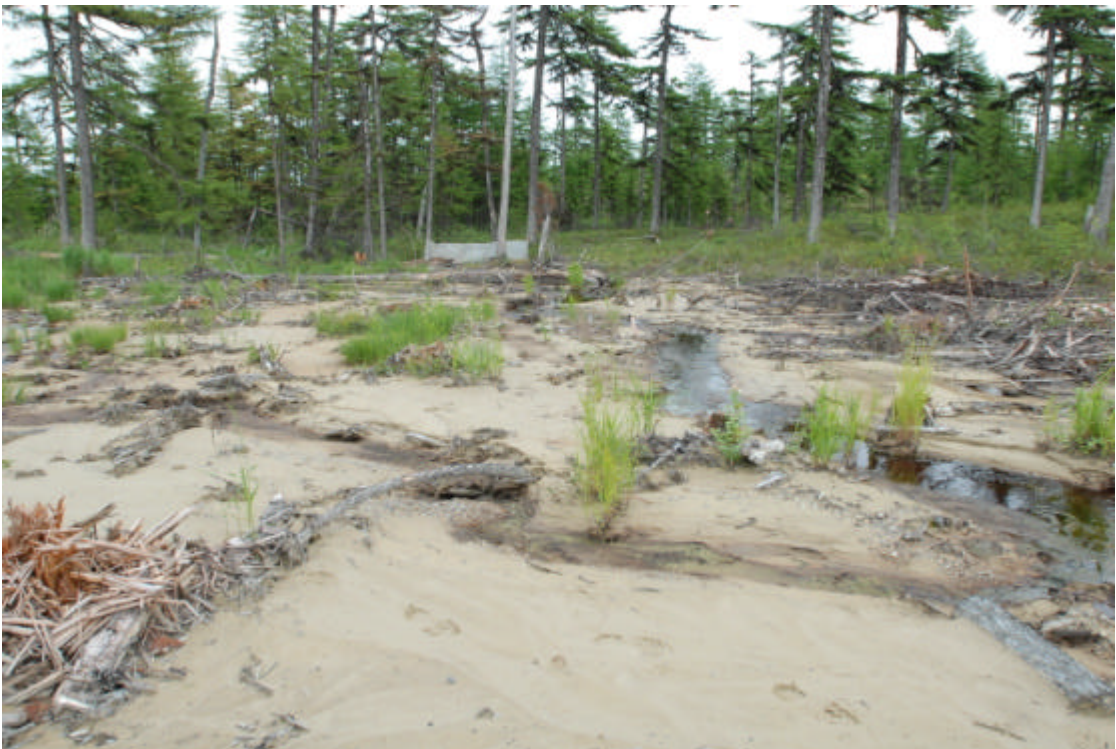
- We observed a considerable amount of soil eroding into the wetland habitat where Spotted Greenshank was found and Sakhalin Energy Investment Company (SEIC) identified as a key habitat. According to SEIC, the destruction was caused by the Exxon pipeline which runs parallel to the SEIC's, but there is already a construction road crossing streams along the planned pipeline route, and the influence of their construction is rather evident. Incidentally, SEIC insists the rivers in this area are small streams without salmon and trout spawning, and therefore, the river system itself is not an object to be protected.

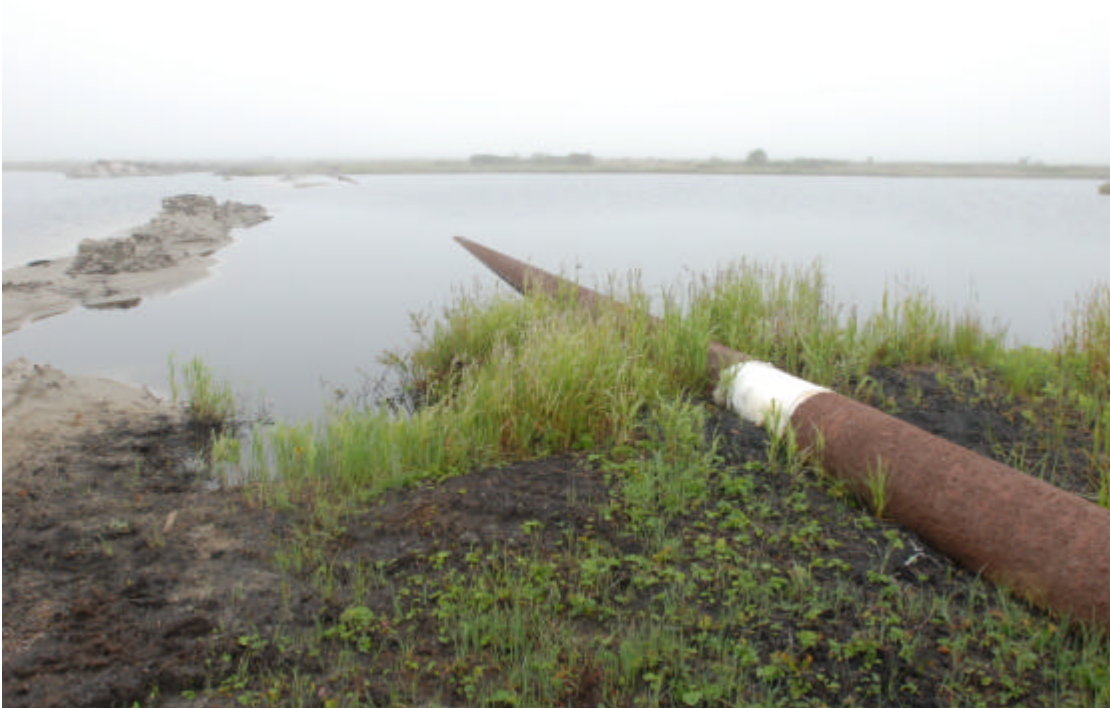
- On the sand spit on the other side of Chaivo Lagoon, most of the pipeline construction were already completed. The pipes laid under water through the wetlands, small lakes and ponds were only treated with surface coating. We did not recognize any special measures taken to prevent oil leak accidents.

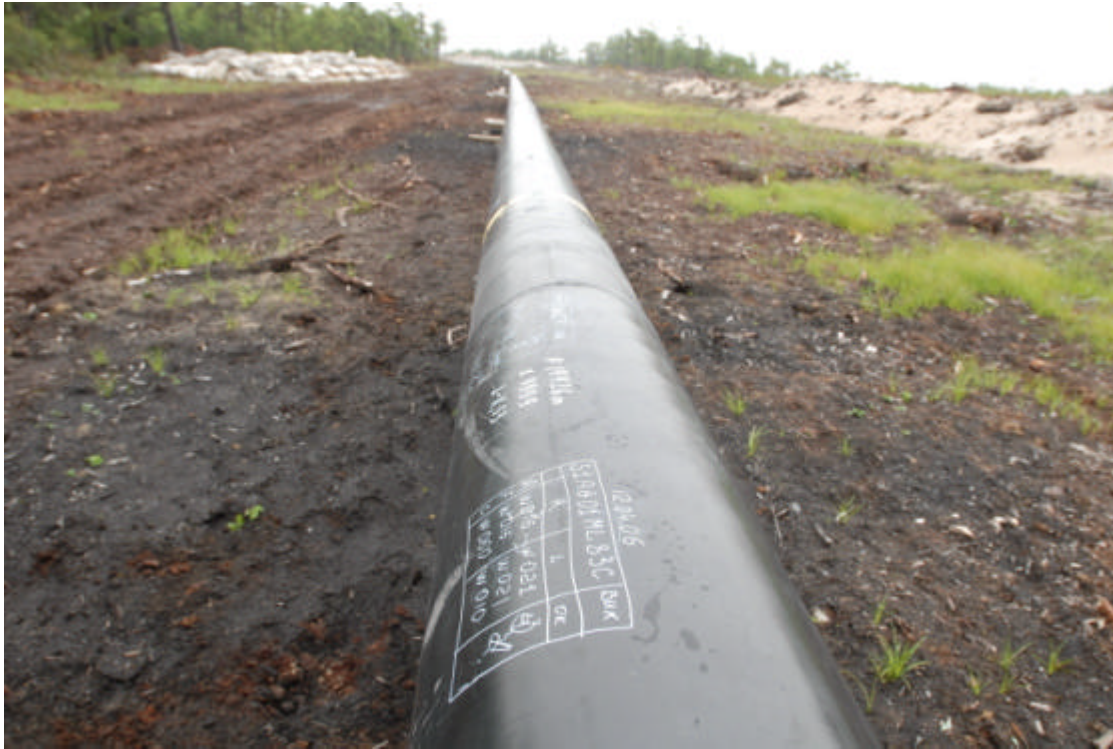
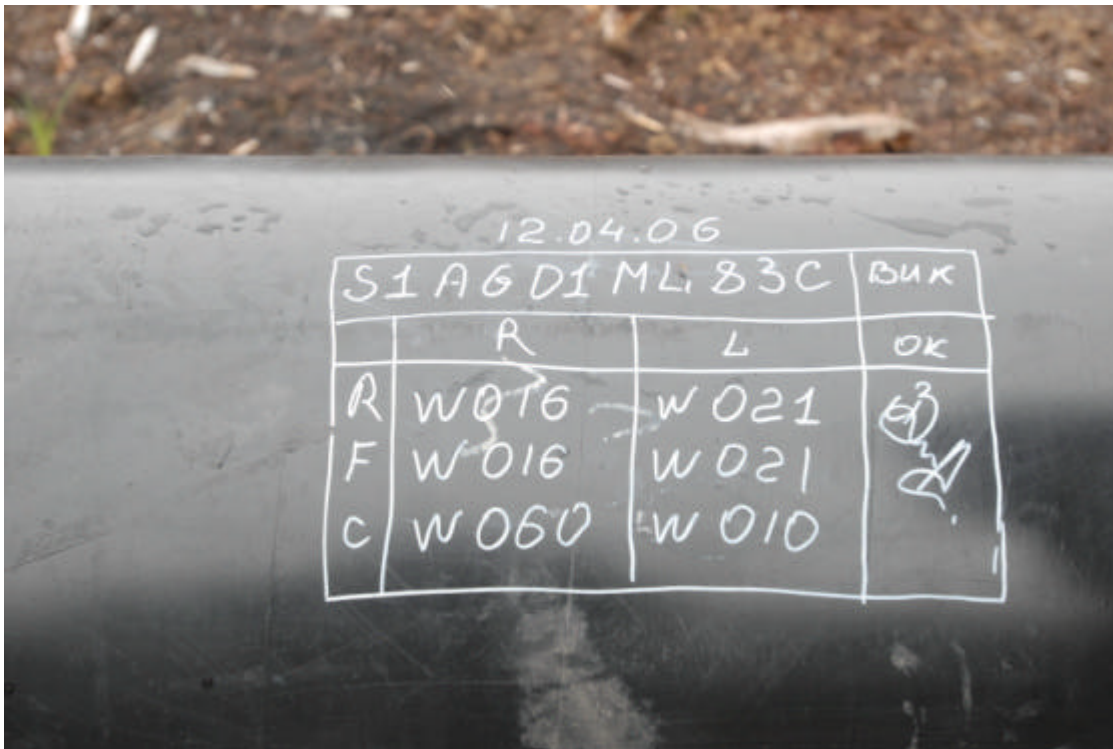
- We observed pipelines constructed only 300 m away from a nest of Steller's Sea-Eagles on the spit across the lagoon. SEIC's on-site staff member explained to us that no construction activities had been taken place within 700 m radius from the nest after March 15<sup>th</sup> as a mitigation measure. We read, however, the work completion date written on 2 pipelines (2 sectors) were April 12<sup>th</sup>, 2006. (Both of

them were newly printed beside the old dates of mid March. )

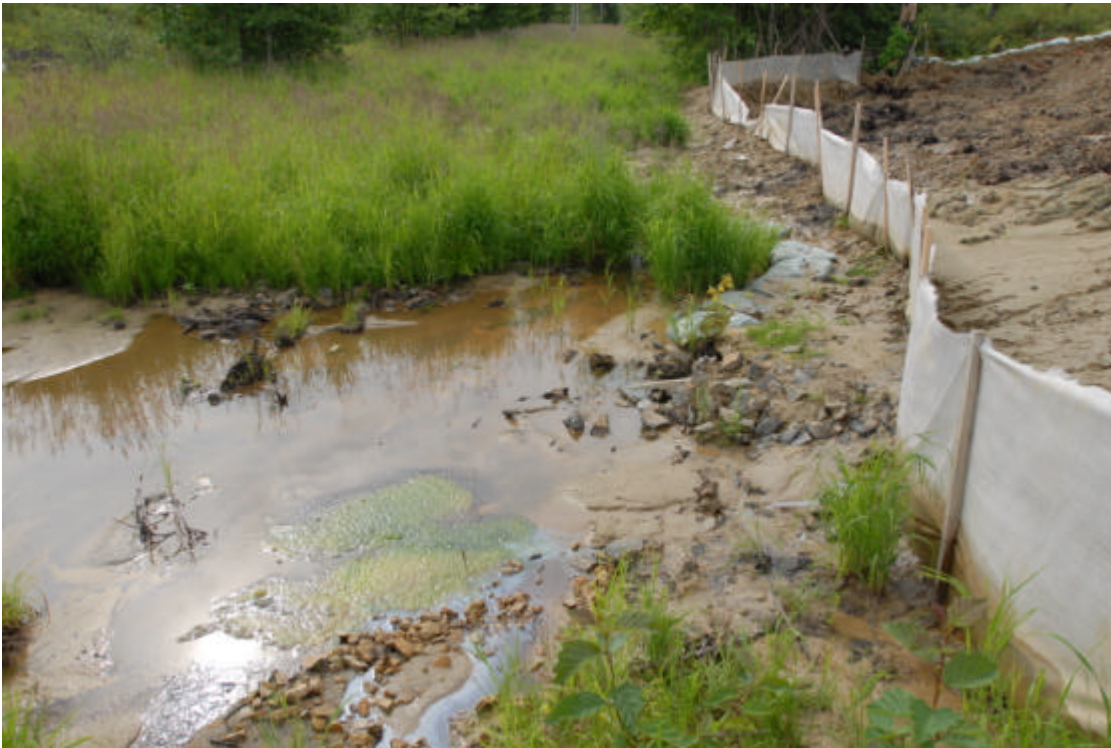
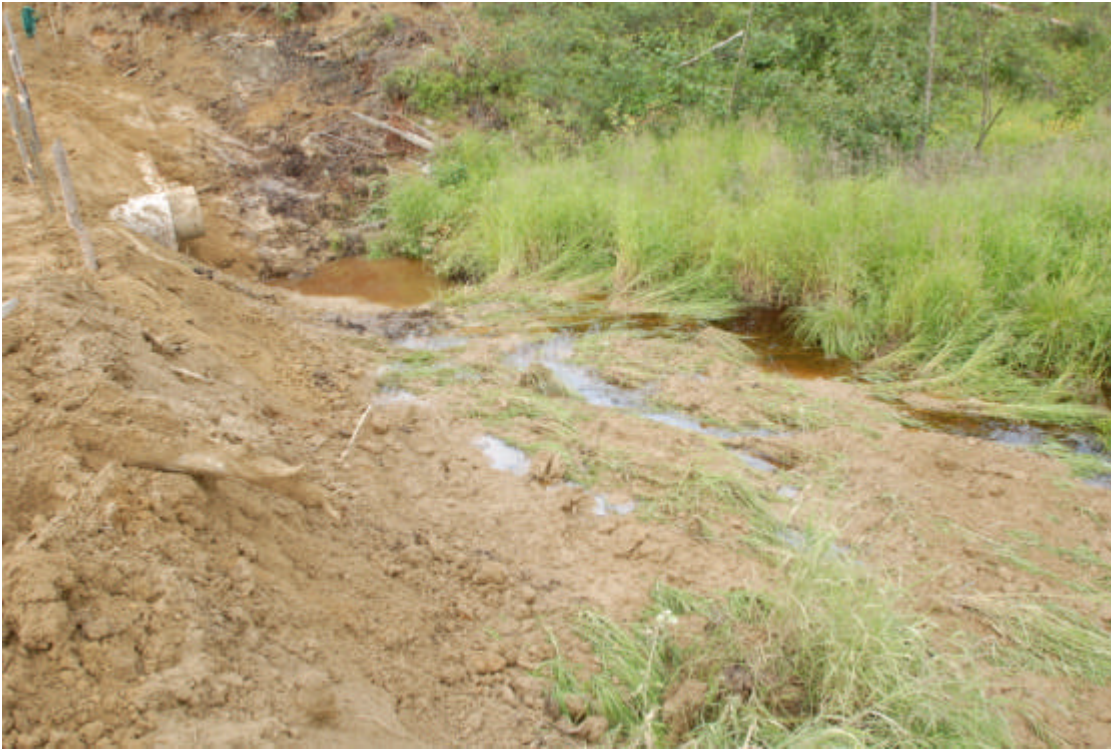
- We observed soil eroding into marshes along several streams which were supposed to be non-salmon/trout spawning rivers (including some streams with treatments done). An on-site staff member of SEIC clearly stated that even for the salmon-trout spawning rivers where some mud-blocking treatments were installed, it will be necessary to repair those fences (made of cloth) at every rainfall. We can speculate that soil erosions into rivers/streams and marshes were extremely common.

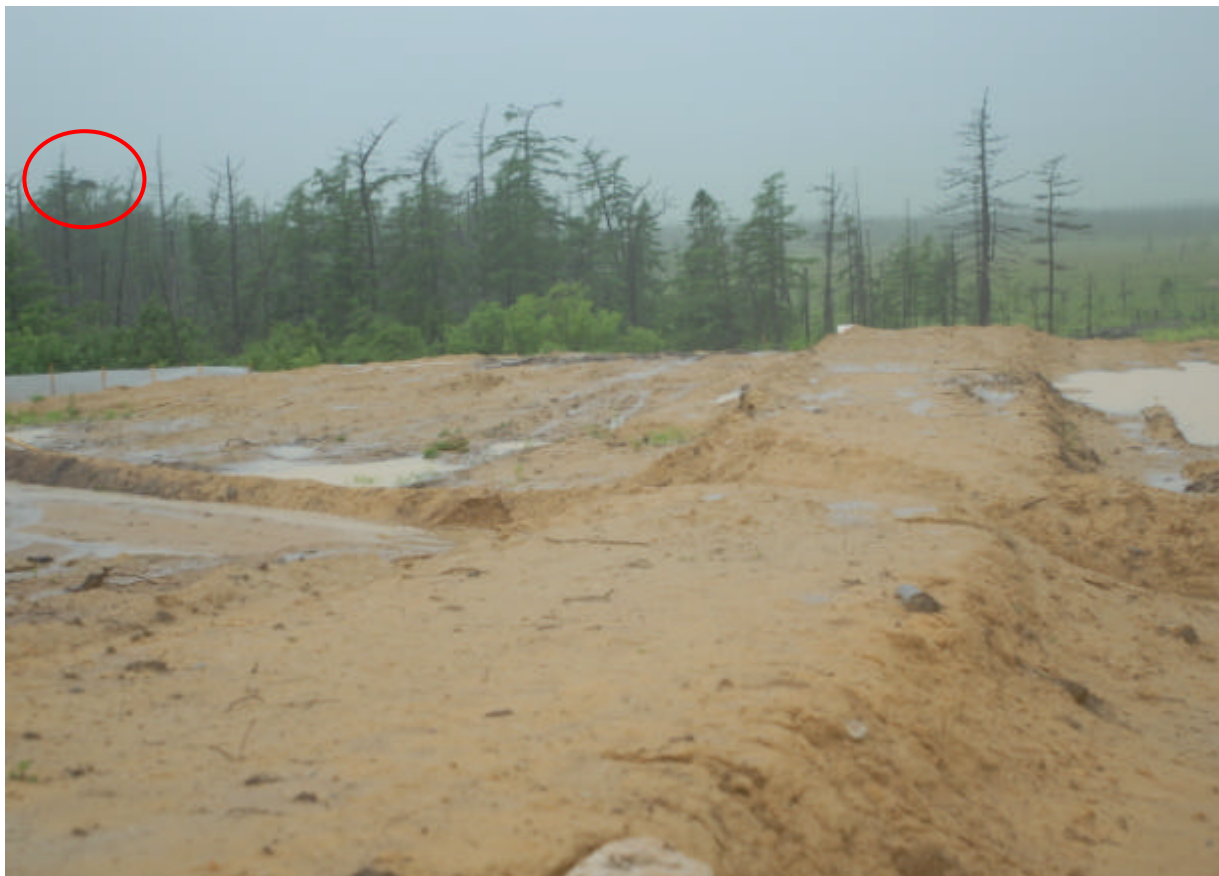
- We observed an active nest of Steller's Sea-Eagles approximately 100 m from the (pipeline) crossing over Tomi River, which flowed into Dagi Lagoon (we confirmed at least one fledgling in the nest). Besides this active nest, we observed another nest of the same pair within 100 m across the pipeline (we confirmed one adult bird near the nest). Also, a few hundred meters farther from the nest, a third nest which most likely belonged to the same pair was observed. It indicated that the pipeline was dividing the breeding pair's exclusive nesting territory (crucial area necessary for reproductive activities) into two. The nesting territory was located in riverside forest only left among the wide area burnt by wild fires, and it could be assumed there were very few other places left as good nesting sites except this location. Furthermore, as we observed more than one nest within extremely close range. It was apparent that the pair had been using this location as a nesting site for many years. It is very difficult to understand why this location was not avoided during the pipeline route planning.

Steller's Sea-Eagle's active nest in circle

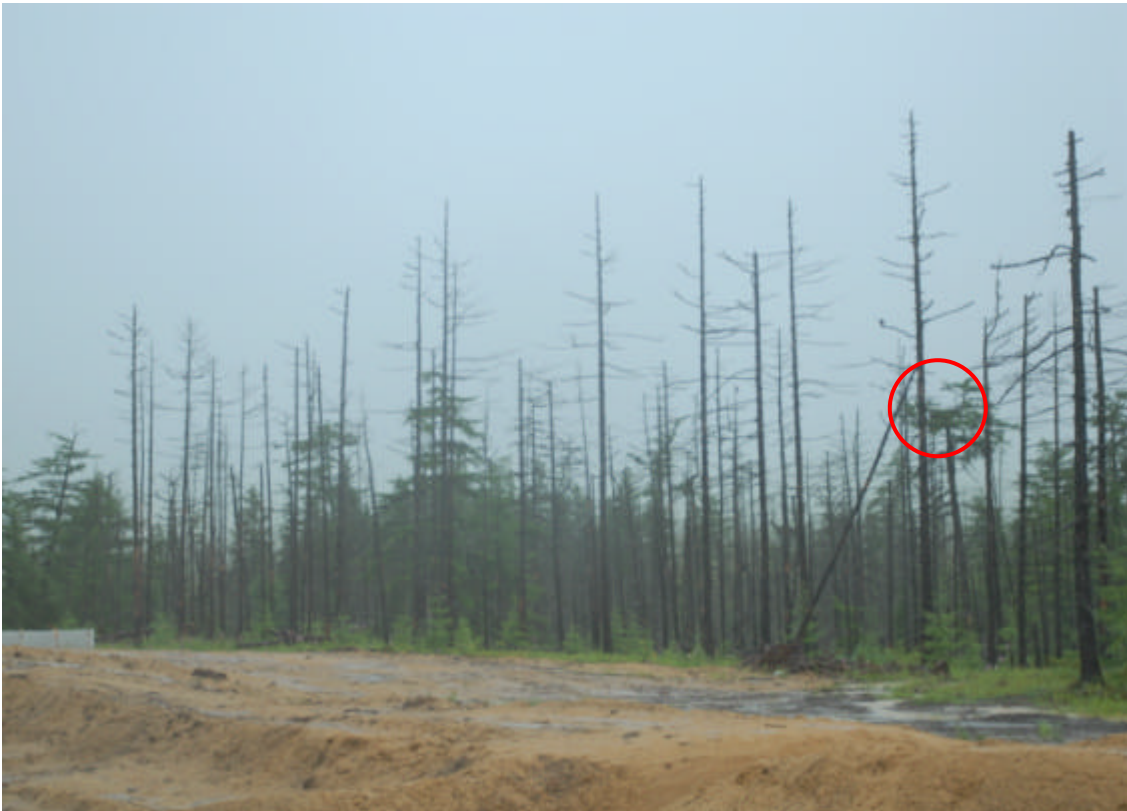
We also observed that the notice signs and fences (at 2 places) to indicate Steller's Sea-Eagles' nesting sites were apparently new, compared to other construction-related objects. According to preliminary information from a local source, there could be no clear signs and fences to restrict the entries into the

Steller's Sea-Eagle's nest in circle

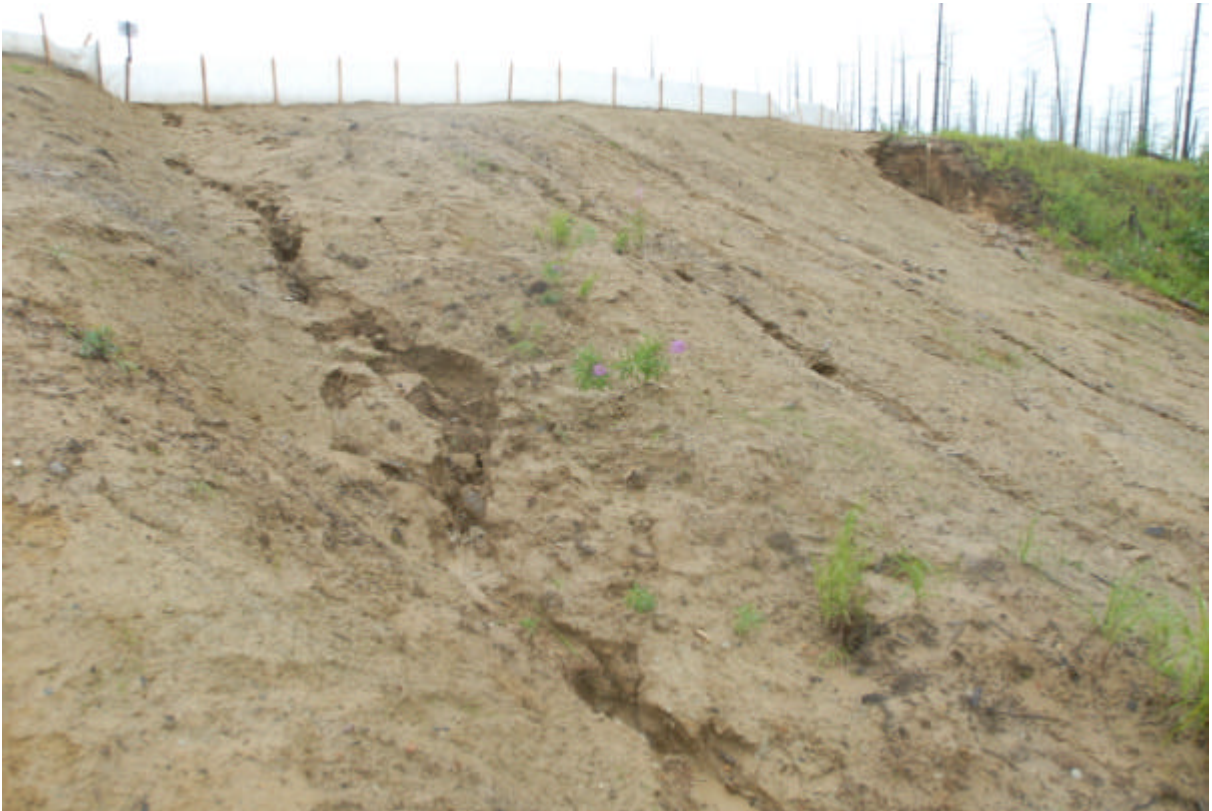
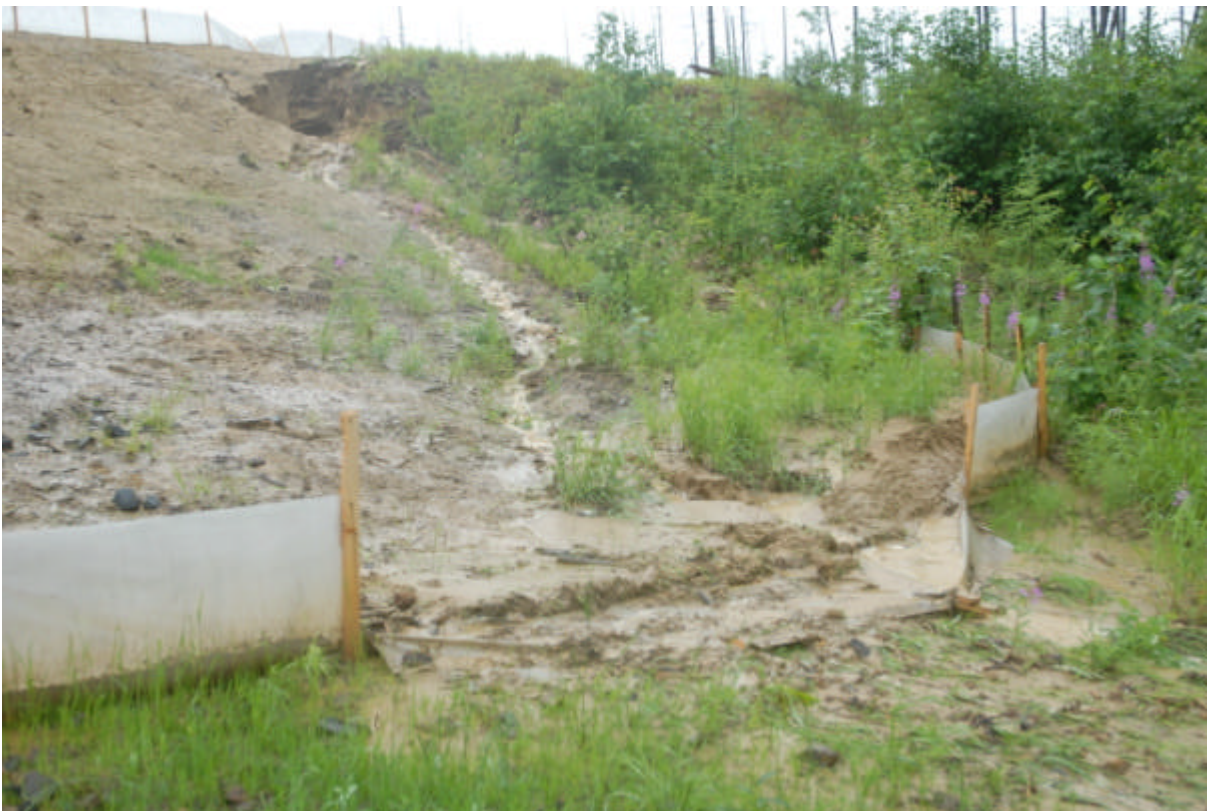
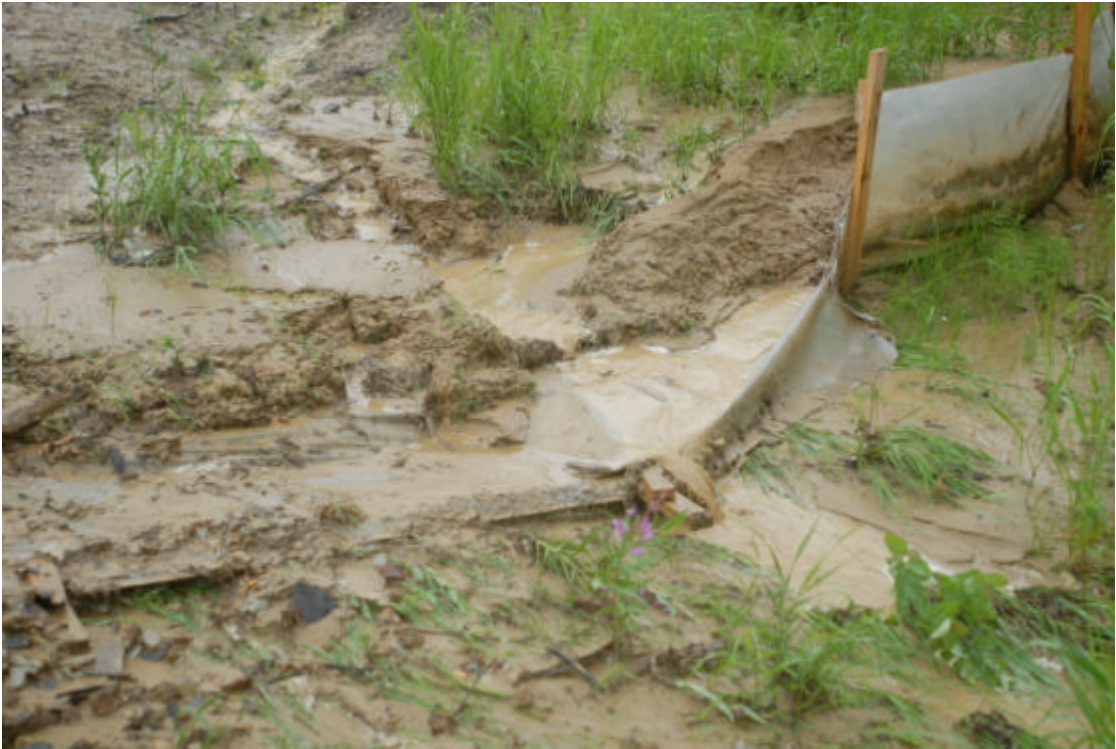
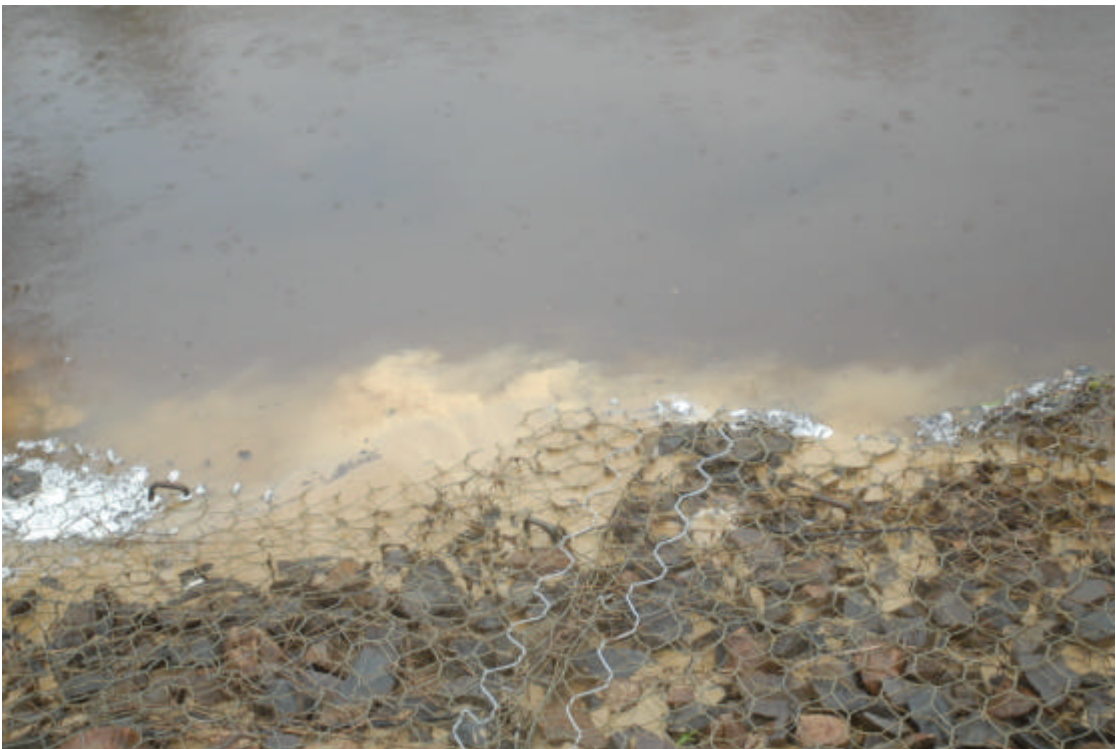
- The construction work on the pipeline crossing Tomi River had been mostly completed in winter time, but we observed several cases of soil erosions and mud inflows into river systems on bare river banks. The company employee stated that they could not do maintenance work as the sites were close to eagle's nests, but the cause of the problems was the pipeline itself which they had constructed in the Steller's Sea-Eagles breeding range in first place. We think this kind of problems were predictable beforehand, and it is interesting to hear what kind of maintenance procedures were being planned for this area.

In order to prevent/mitigate the influences of the development on the environment, especially on wildlife, we believe that following steps should be considered:

**Habitat Protection:** Securing sufficient distances between the key habitats of wildlife (breeding ground, feeding ground, migration routes, etc.) and the construction sites that would influence the ecosystem.

**Risk Prevention:** Careful selections of the development areas and sufficient risk prevention measures in order to be prepared for accidents such as oil leaks (besides areas).

**Mitigation of the Development's Direct Influence :** Careful selections of construction time and methods in order to minimize the influence on wildlife found around the development areas.
